# Challenges and Solutions During the Re-Lining of a Concrete Covered Water Reservoir

Brian Fraser & Mike Neal  
Layfield Geosynthetics, Edmonton, Alberta  
e-mail: [Brian.Fraser@layfieldgroup.com](mailto:Brian.Fraser@layfieldgroup.com) | [mike.neal@layfieldgroup.com](mailto:mike.neal@layfieldgroup.com)

**THIS PAPER WAS ORIGINALLY PRESENTED AT THE 2009 GEOSYNTHETICS CONFERENCE | SALT LAKE CITY, UT, USA**

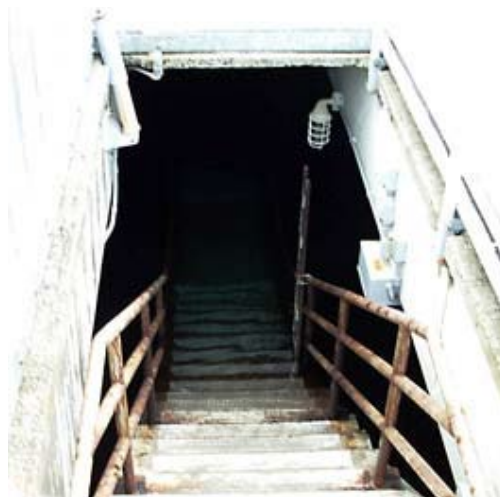
All underground concrete reservoirs have limited access. In this reservoir there were only two 1.2 x 3.6 m (4' x 12') roof hatches on the south side of the reservoir located near the perimeter. One hatch was directly over a concrete stairway and the other was adjacent to it at the top of the slope. Although the staircase was adequate for personnel access, for materials and equipment it was severely limited. It was determined that the limited access would make it very difficult and time consuming to remove the existing geomembrane, geotextiles, and anchor system and replace them with new materials. These hatch locations required that the project materials and equipment be either carried or slid down the narrow stairs into the reservoir. The two existing hatches in the same relative location would also limit air circulation for the workers.

Figure 2. Main hatch showing restricted entrance

To address this issue Layfield commissioned the design and construction of a new equipment hatch that was placed on the opposite side of the reservoir and located over the toe of slope. By locating a hatch over the toe of the slope the materials could be lowered directly to the base of the reservoir. This allowed the heavy materials to be moved in and out of the reservoir with a crane. The new hatch was located so that City water operators had a direct view of the main inlet pipe. This would let them

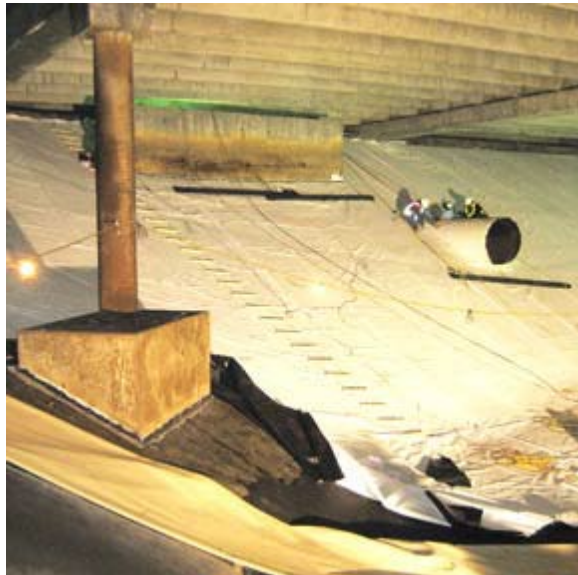
*Figure 5. Surge tube (beige tube in foreground) directing surge water to the primary drain. Note the 1.2m (48") pipe boot and sloped column support in the background*

To address this concern, Layfield fabricated and supplied a 2 m (6.6') layflat bypass tube from reinforced Polypropylene. This tube was attached to the 1.2 m (48") surge in-flow pipe and extended into the primary drain in the bottom of the reservoir. This allowed incoming surge water to be directed to the drain inlet during construction. As a further back up, Layfield had on site two portable coffer dams (Aqua Dams®) that could be filled with water to dam off a section of the reservoir if the surge water tube unexpectedly didn't work. A plan was in place to inflate the two water-filled coffer dams in the event of an emergency using water from an available hydrant. This back-up plan would then allow time to retrieve equipment and to try and shut off the surge water. During the construction of this project we experienced about two to three surges per day, from a small trickle, to significant water flows. The bypass tube worked as designed and was removed after the final liner tie-in at the completion of the project.

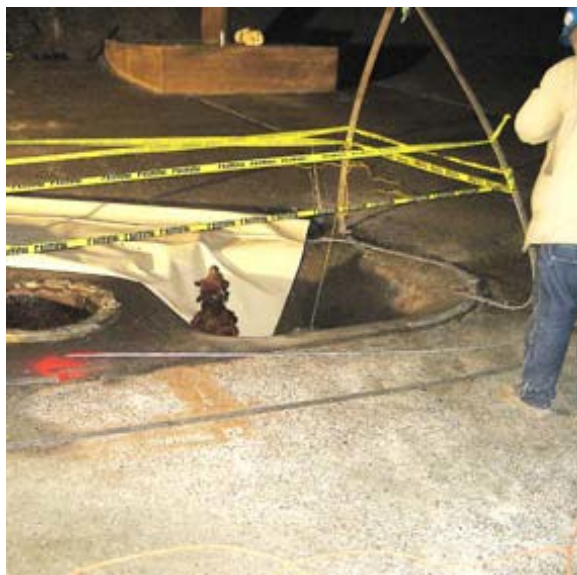
*Figure 4. Surge tube leading into a small bypass outlet that connects to the main drain (circular opening on the left)*

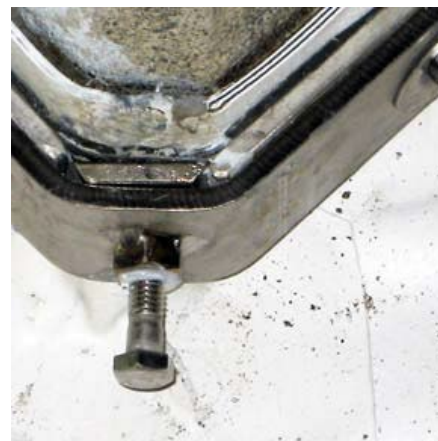
Underground reservoirs usually have a great deal of liner attachments due to the roof supports. This reservoir had a few additional challenges. Seven inlet pipes required waterproof pipe boots including sizes up to 1.2 m (48"). There were the expected 32 column footings that required water tight connections, but there were also four column footings located on the slopes requiring a much more complicated attachment. Finally there was a 100 m (300') long seismic beam in the center of the reservoir that required over 230 m (750') of water tight attachment. A particular challenge was to attach the liner to the vertical face of the column supports. This is a challenging connection as it is difficult to maintain batten bar pressure around the point of the corner.

Figure 7. Special corner clamp to maintain pressure at the point of the concrete footing.

challenged by tight space constraints, concrete remedial work, and dewatering requirements. To address the problem of sealing around concrete corners, Layfield designed and fabricated special compression corner clamps (Figure 7). The complicated penetrations and attachments in this project required a lot of time and detail.

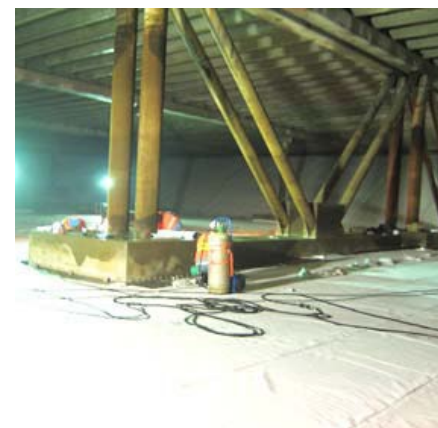
Figure 8. Attaching the geomembrane to the large seismic beam in the center of the reservoir.

Layfield followed the guidelines of ASTM D6497 for pipe boots and attachments. For attachments on this project, 6 mm x 50 mm (¼" x 2") 316 stainless steel batten bars and 9.5 mm (3/8") 316 stainless steel anchor bolts on 150 mm (6") centers were used. The four slope columns used the same batten system modified to accommodate the slope. The pipe boots followed the standard industry attachment guidelines but were

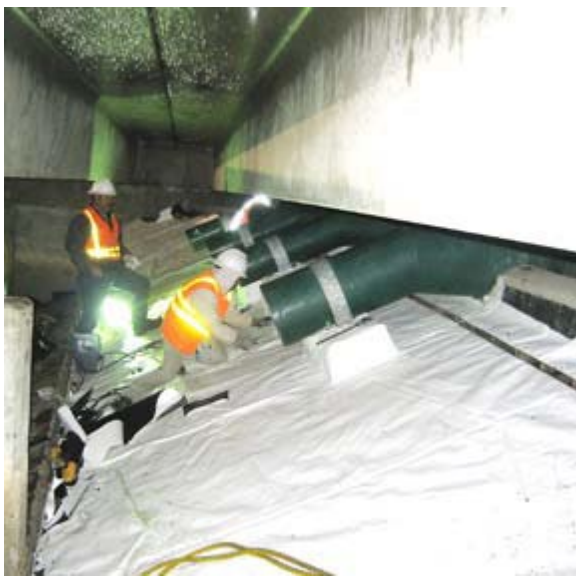
Figure 10. Sealing the liner under multiple small inlet pipes.

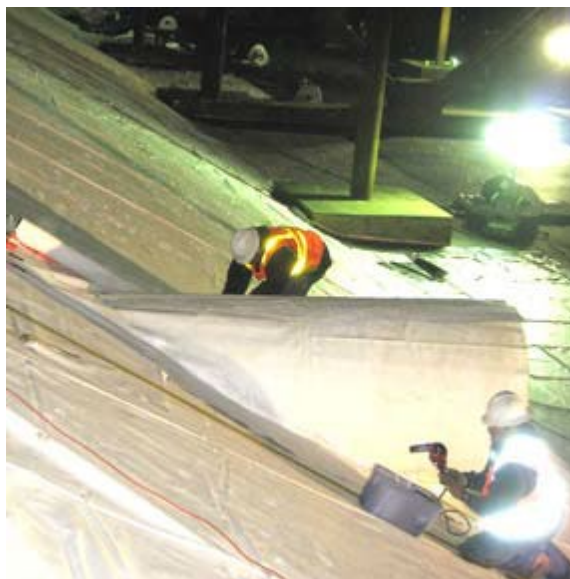
Figure 9. A boot on a large 1.2m (48") inlet pipe.

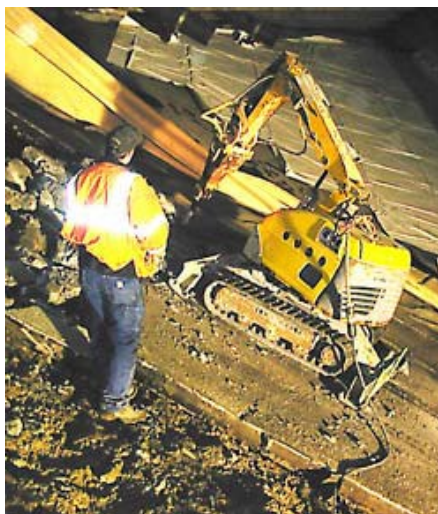
The failure of the first geomembrane led to significant damage in two of the reservoir's concrete slope panels. The original project scope was limited to filling construction joints prior to re-lining. Once the liner system was removed it was observed that two concrete slope panels had shifted and had significant voids underneath. The damaged panels represented 200 m<sup>2</sup> of unreinforced concrete 150 mm thick (2200 ft<sup>2</sup>, 6" thick). Removal of this 30 m<sup>3</sup> (1000 ft<sup>3</sup>) of concrete was a significant problem as site and entry access for heavy equipment was extremely difficult. To compound this problem, a large amount of new liner material was already in place adjacent to the problem areas.

Figure 13. Remote controlled concrete breaker working on reservoir slope.

After discussions with the City of Everett and various concrete subcontractors a small remotely controlled hydraulic concrete breaker was sourced that could be lowered into the reservoir through the new equipment hatch. This electric unit did not generate fumes in the reservoir and had tracks so that it was stable on the slopes. The broken concrete and saturated subsurface materials were manually moved to a skip underneath the new equipment hatch and lifted out with a crane. New waterstops were added and then the concrete replaced with a concrete pump. The entire space was filled with concrete as it was not possible to compact any new fill materials with available equipment. Although one panel was located about 12 m (40 ft) horizontally from the new equipment hatch the subcontractor was able to pump the concrete without too much difficulty. The unexpected concrete problems resulted in a major project change order; however, the sequence of the installation was changed to give the subcontractor time to remove and repair the old concrete without affecting the schedule. Even with this change the project was completed within the original 55-day schedule.

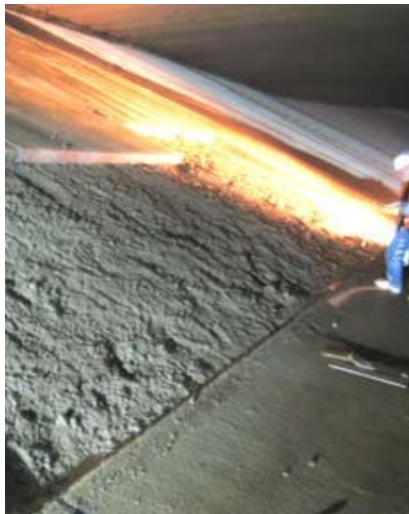
Figure 12. Once the concrete was removed an engineer determined how much of the saturated subgrade to remove.

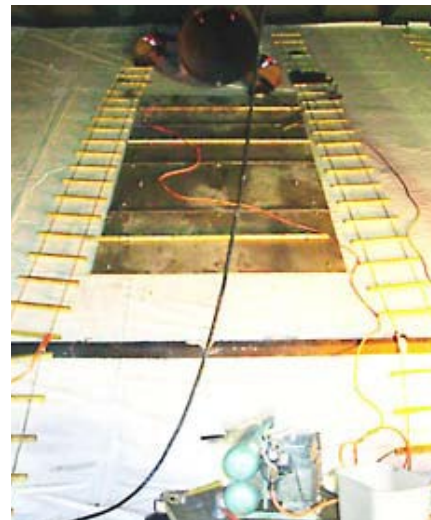
Figure 11. Stainless steel splash plate during installation.

The original liner had failed because the geomembrane had eroded on the slope underneath the inlet pipe. The contract specified that a 2.4 m wide x 6 m long, 6 mm thick (8'x20', 1/4") stainless steel splash plate be installed to protect the liner system under the main 48" inlet pipe. The challenge was to place this 2000 pound piece of stainless steel 6 m (20') up the side slope without the use of heavy equipment. Not only was the weight a problem but the concrete on the slope was uneven making it very difficult to make a watertight seal.

A number of alternative splash pad designs were investigated. Finally a proposal was put forward to build the stainless steel splash plate in sections. Each section would be 1.5 m x 2.4 m (5' by 8'). A strip of stainless steel 6.35 mm (1/4") thick by 10.16 cm (4") wide was welded across the top of each section to form a joint. These joints were shingled in the direction of water flow. The side slope was lined with geomembrane underneath this splash plate and then the plate was placed on top of a protective wear pad on the liner. Neoprene gaskets were placed around the perimeter of the splash plate sections and each section of the plate was secured with a pattern of 12 mm (1/2") stainless steel bolts. Since the splash plate did not need to contain water (the geomembrane is continuous underneath it) it is not sealed between sections.

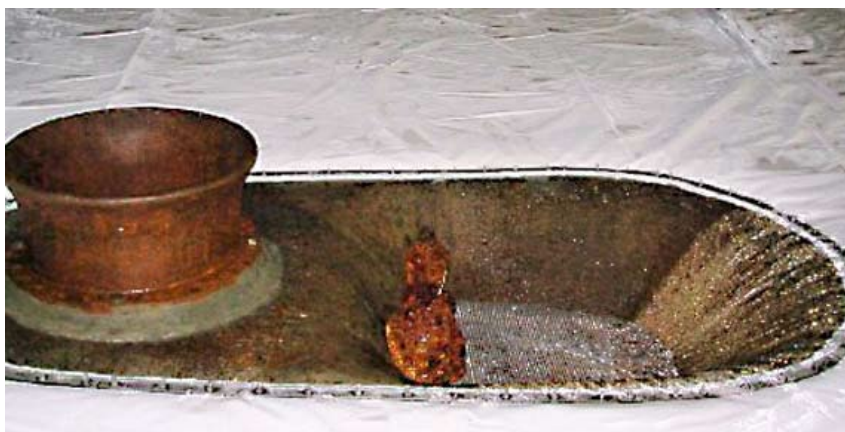
*Figure 14. The primary drain after liner installation and disinfection. The bell standpipe is for normal drainage and is designed to exclude silt. The dished section on the right is a small bypass for draining of the reservoir completely.*

The disinfection method requires that a 50 ppm sodium hypochlorite solution be applied to the reservoir during initial fill. After working with the City on flow calculations and water quantities it was decided to bring in several 55 gallon drums of 12% sodium hypochlorite. The drums were placed at the new equipment hatch and a chemical feed pump was used to pump the sodium hypochlorite solution into a plastic hose that was placed directly in front of the inlet pipe to allow the mixing of the sodium hypochlorite with the inlet water as it cascaded down the splash pad.
