# Challenges and Solutions During the Re-Lining of a Concrete Covered Water Reservoir

Brian Fraser & Mike Neal  
Layfield Geosynthetics, Edmonton, Alberta  
e-mail: [Brian.Fraser@layfieldgroup.com](mailto:Brian.Fraser@layfieldgroup.com) | [mike.neal@layfieldgroup.com](mailto:mike.neal@layfieldgroup.com)

**THIS PAPER WAS ORIGINALLY PRESENTED AT THE 2009 GEOSYNTHETICS CONFERENCE | SALT LAKE CITY, UT, USA**

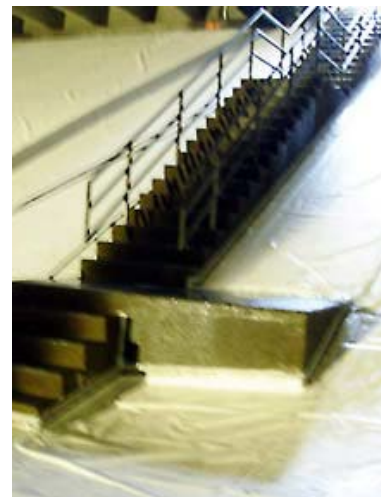
Figure 3. Staircase inside reservoir

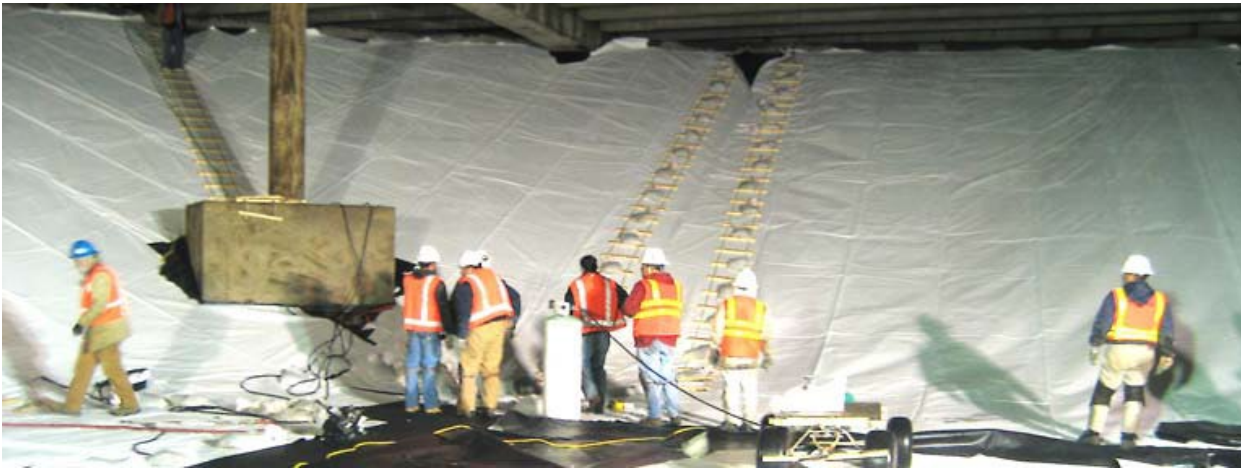
Figure 6. Workers in reservoir showing PPE, hand cart for moving heavy objects, and rope ladders for slope safety.

This site required a custom designed safety program. This document included site specific requirements to deal with surge water, emergency egress, power failure procedures, and air safety. High output fans were required at the new equipment hatch to create sufficient air turn over to protect workers in the reservoir. This was backed up with air quality monitoring devices within the confined area. An evacuation procedure was developed in the event of a power failure. All personnel on site were trained on this procedure.
